IRAQ

Core Housing Units for Post-Conflict Returnees

PROJECT DESCRIPTION

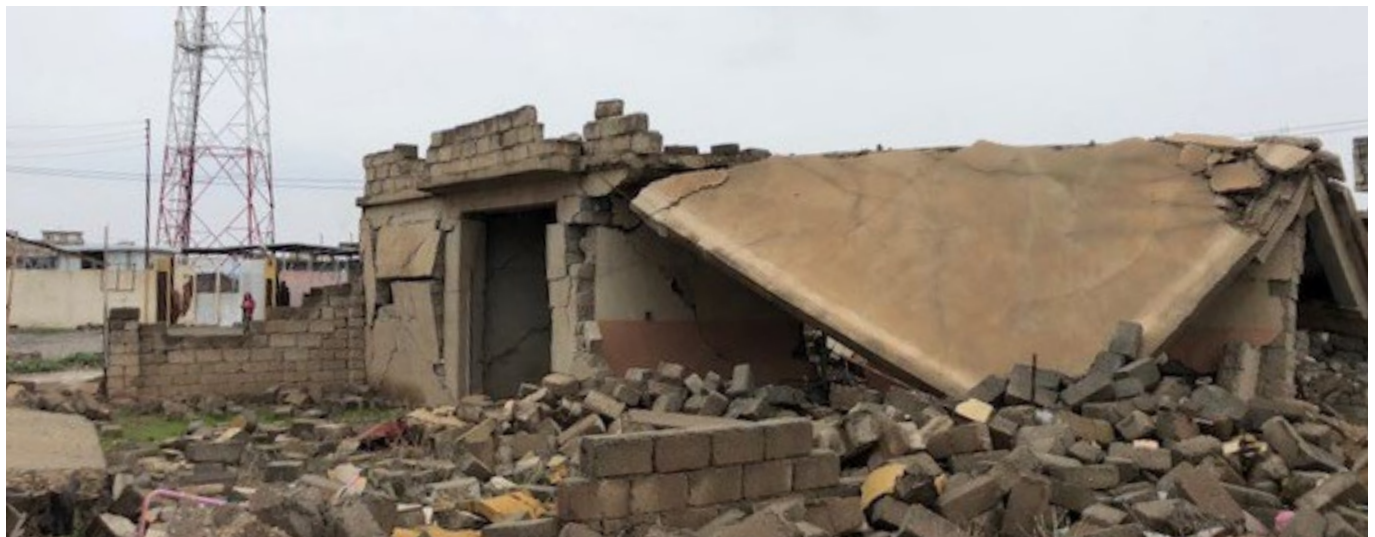
Totally damaged house in Kharaba Sultan village of Ninawa, Iraq. Photo: CRS

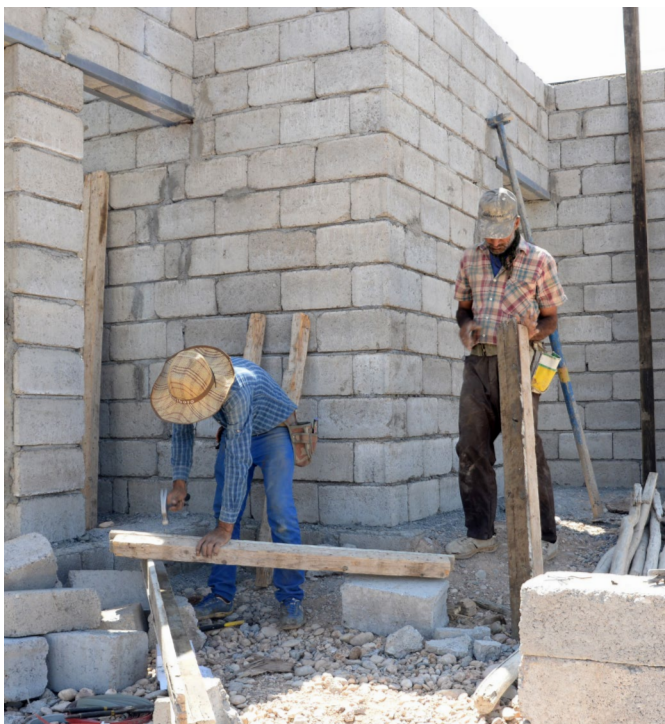
Building walls and molding for reinforced concrete roof of the core housing unit in Tobzawa village of Ninawa, Iraq.

Load-bearing walls were made from concrete blocks that were plastered externally with cement, and internally with gypsum. This was due to the local availability of cement, gypsum and aggregates, and that most of the houses in Ninawa are built with concrete.
